DOE/ID-10750

***Institutional Controls Status Report at
Test Area North, Waste Area Group 1***

Published May 2000

**Prepared for the
U.S. Department of Energy
Idaho Operations Office**

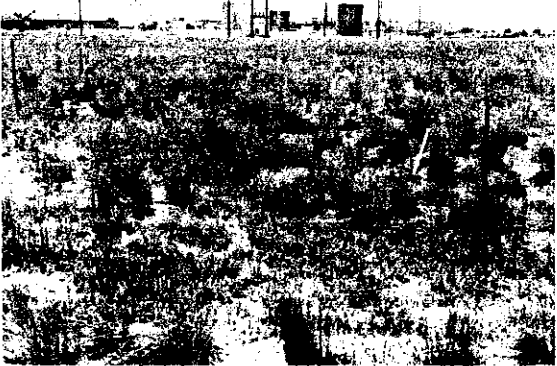
<p align="center">TSF-03 Burn Pit</p>	<p align="center">Facility Security Fence</p>	<p align="center">Signs</p>	<p align="center">Fences</p>	<p align="center">Other</p>	<p align="center">Administrative for Access to the Site</p>	<p align="center">Administrative to Work at the Site</p>
<p>History: The TSF-03 Burn Pit is located northwest of Columbia Street gate access, outside the TSF facility fence. The Burn Pit was potentially used for open burning of combustible waste from 1953 to 1958. The site has been backfilled, subsidence control has been maintained, and vegetation has been reestablished. The pit received refuse, construction debris, and combustible liquids (i.e., petroleum products) from the TAN areas. It is possible that some oil, Stoddard solvent, and oily waste (from the limited maintenance activities at TAN) were burned at the pit.</p> <p>Contaminant of Concern: lead</p> <p>Action: Remedial action is to install native soil cover. A contingency remedy is excavation and disposal of contaminated soil.</p>	<p align="center">No</p>	<p align="center">Environmental Control Sign</p>	<p align="center">Yes, gate open</p>	<p align="center">No</p>	<p align="center">Access control, sign in</p>	<p align="center">STD-101</p>

<p>Comments</p> <p>This site was closed to all personnel during March 2000. Notes from inspection of November 3, 1999, were used.</p>					
<p align="center">Photo File: PN 99-0405-4-28</p>	<p align="center">Inspection Date: November 3, 1999</p>

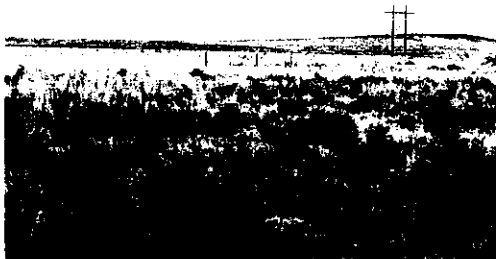
WRRTF-01 Burn Pits I, II, III, IV		Facility Security Fence	Signs	Fences	Other	Administrative for Access to the Site	Administrative to Work at the Site
<p>History: The WRRTF Burn Pits are located approximately 823 m (2,700 ft) north of WRRTF. These burn pits were used for open burning of combustible waste generated at the TAN facilities from 1958 to 1975, and involved four separate areas. Burn Pit I opened after TSF-03 Burn Pit was filled, and received both combustible solids and liquids from 1958 to 1964. Burn Pits II and III were opened after Burn Pit I was filled and operated from 1964 to 1970. Burn Pit II also may have received only combustible solids while Burn Pit III received only combustible liquids. Burn Pit III received petroleum products. Burn Pit IV was opened because Burn Pit II was filled and received mainly combustible solids and some reportedly noncombustible solids (automobiles, metal goods, etc.) Minor amounts of combustible liquids may have been disposed of in Burn Pit IV. No RCRA wastes are suspected of having been disposed of at these sites. The sites have been backfilled and vegetation reestablished; however, at Pits I, II, and IV subsidence control has not been maintained.</p> <p>Contaminant of Concern: lead</p> <p>Action: Remedial action is to install native soil cover. A contingency remedy is excavation and disposal of contaminated soil.</p>		No	Yes	No	No	There are signs on public accesses limiting unauthorized travel on site	STD-101

<p>Comments</p> <p>The corners of each burn pit is marked with a rebar stake.</p> <p>Inspection Date: March 23, 2000</p>					
<p>Photo File: PN000128-02</p>

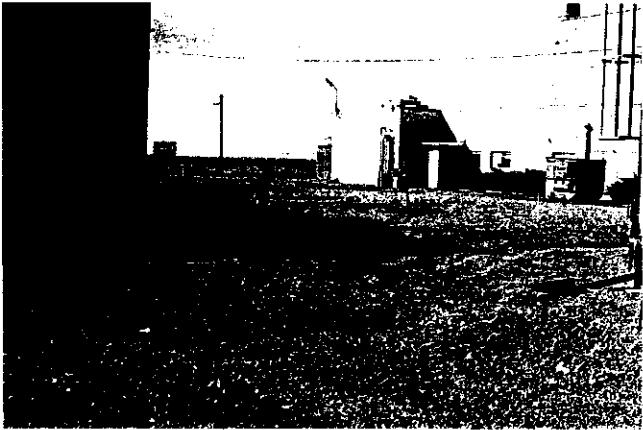
<p align="center">Photo File: PN000128-04</p>	<p>Inspection Date: March 23, 2000</p>

<p align="center">WRRTF-13 Fuel Leak</p>	Facility Security Fence	Signs	Fences	Other	Administrative for Access to the Site	Administrative to Work at the Site
<p>History: WRRTF-13 is the environmental contamination associated with the diesel fuel oil discovered at the WRRTF-05 injection well in November 1993. The results of the OU 1-08 Track 2 investigation indicate soil contamination at WRRTF-13 is at depth (5 ft or greater) and contaminants detected at the site were found at relatively low concentrations.</p> <p>Contaminant of Concern: petroleum hydrocarbons</p> <p>Action: The selected remedy includes sampling, excavation and land farming of contaminated soil, backfilling with clean soil, contouring and grading to surrounding soil.</p>	Yes	No	Yes		Guard gate, card reader access, POD	POD, STD-101

<p>Comments:</p> <p>Sign was present but broken and fallen.</p> <p>Notification to facility manager required for entry.</p>

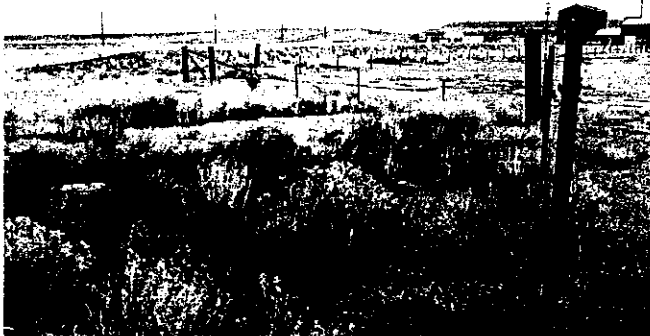
TSF-06, Area 5 Radioactive Soil Berm		Facility Security Fence	Signs	Fences	Other	Administrative for Access to the Site	Administrative to Work at the Site
<p>History: TSF-06 is a large, open, soil area with elevated levels of radioactive contamination, which also contains 13 subareas with discrete boundaries and types of contaminants. The main contaminants of concern are Cs-137, Co-60, and Sr-90. Source of contamination in Area B is windblown contamination from soil surrounding the PM-2A tanks (TSF-26).</p> <p>Contaminant of Potential Concern: radionuclides.</p> <p>Action: No Action Site requiring institutional control.</p>		Yes	Yes	Yes	Gated entry point by bully barn	Access restricted, RWP, POD	RWP, POD, STD-101

<p>Comments:</p> <p>Site within TSF-06 area fence.</p>					
<p>Photo File: PN000128-21</p>		<p>Inspection Date: March 23, 2000</p>

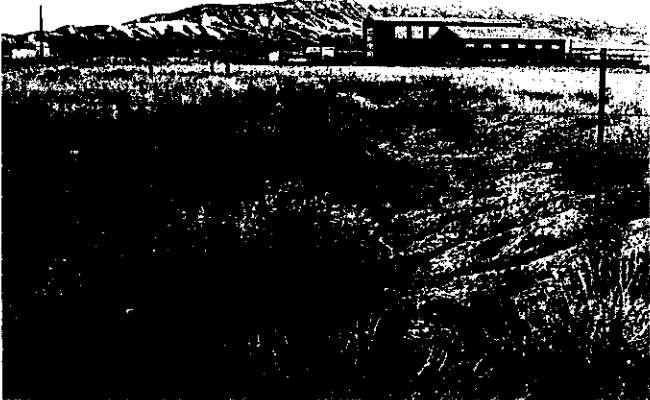
Photo File: PN000128-24		Inspection Date: March 23, 2000

TSF-06, Area 11 TSF-06 Ditch		Facility Security Fence	Signs	Fences	Other	Administrative for Access to the Site	Administrative to Work at the Site
History: TSF-06 is a large, open, soil area with elevated levels of radioactive contamination, which also contains 13 subareas with discrete boundaries and types of contaminants. The main contaminants of concern are Cs-137, Co-60, and Sr-90. Source of contamination in Area B is windblown contamination from soil surrounding the PM-2A Tanks (TSF-26). Contaminant of Potential Concern: radionuclides. Action: No Action Site requiring institutional control.		Yes	Yes	Yes	Gated entry point by bully barn	Access restricted, RWP, POD	RWP, POD, STD-101

Comments: Site is within TSF-06 area fence. The "Y" shaped ditch is of concern in two areas only; the west end of the ditch, and the northern leg of the "Y". Photo shows the northern end of the ditch. The remainder of the ditch is clean.

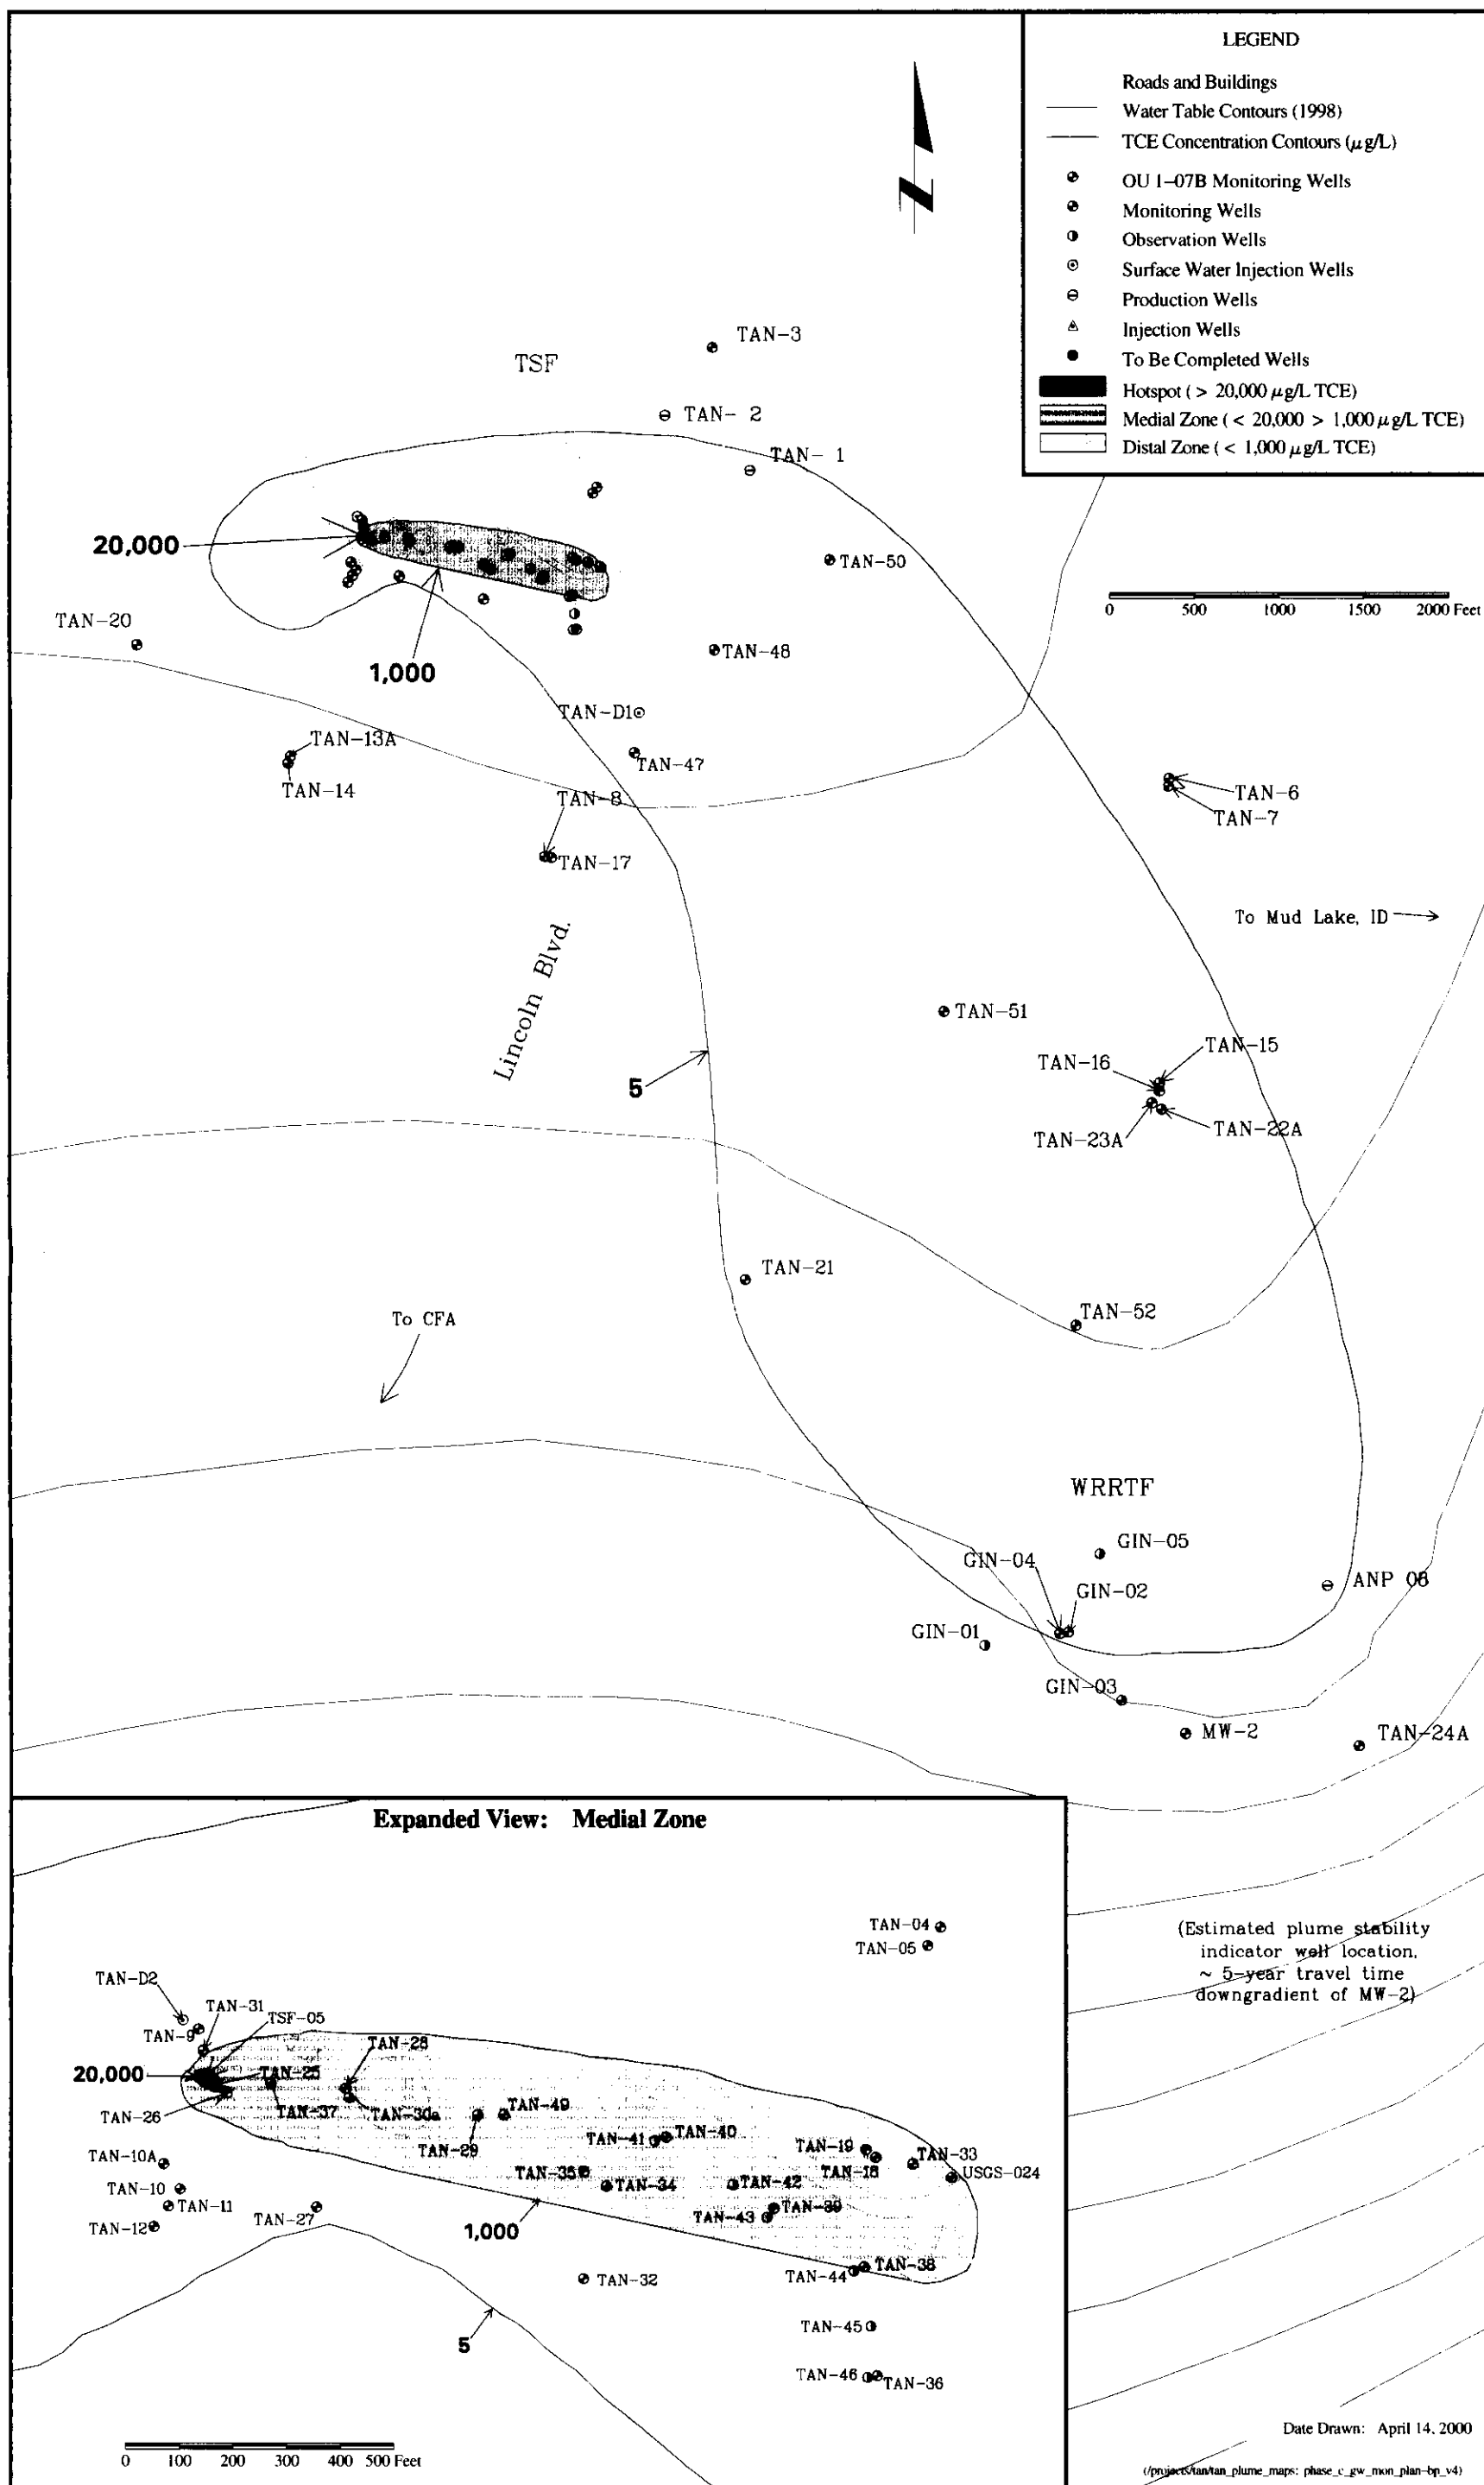
Figure B-1. Well locations in TSF-23.

<p>See Appendix B and Figure B-1 for well locations in TSF-23.</p>		<p>Comments</p> <p>Keys for locked caps on all wells obtained from the OU 1-07B construction engineer.</p> <p>All wells included in the OU 1-07B Phase C Monitoring Plan have been inspected.</p> <p>Inspection Dates: March 23 and 28, 2000</p>
